UNITED STATES ENVIRONMENTAL PROTECTION AGENCY  
REGION 2  
290 BROADWAY  
NEW YORK, NY 10007-1866

Re: City of Middletown  
SPDES Permit No. NYR20A271

United States Environmental Protection Agency  
Washington, D.C. 20460  
**Water Compliance Inspection Report**

**MS4 Inspection Report/City of Middletown, NY  
(NYR20A271) – February 13, 2013 and April 1-4, 2013**

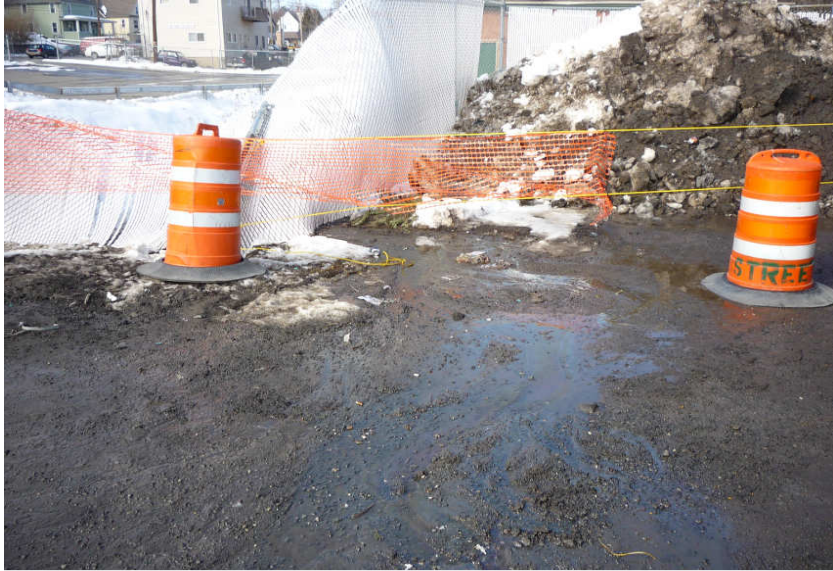
Oil sheens in the Sanitation Garage yard

1. During the February 13, 2013 inspection of the Middletown Sanitation Garage, EPA inspectors noted oil sheens, both outside and inside the facility. Middletown should restrict all flows from vehicle wash down areas are fully controlled by consolidating wash down to indoor garage locations only. We recommend that all vehicle washing and maintenance be accomplished within the interior of the facility. Service personnel should make use of spill aprons to avoid exposure of hydrocarbon contaminants at this facility. Inspectors noted sheens with a high potential to wash along the banks of the creek, entering the surface water, a potential violation of Part VII.A.6. of the SPDES General Permit under the pollution prevention/good housekeeping.

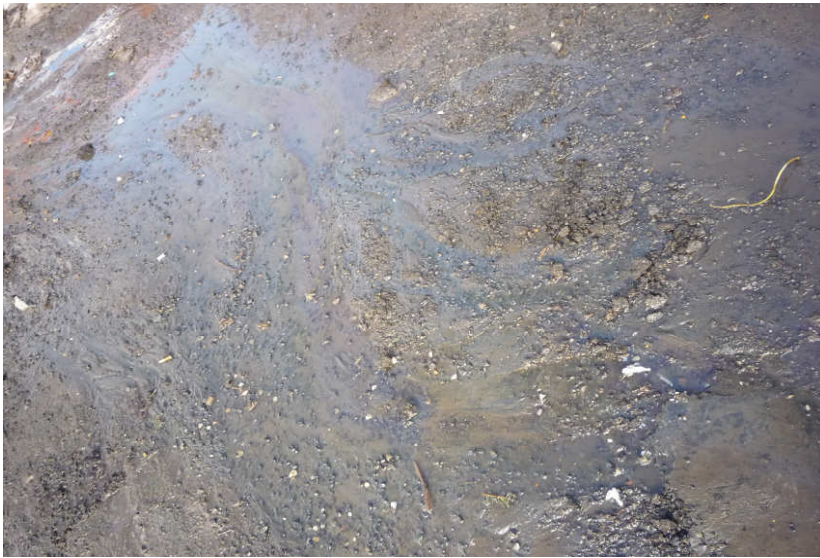
Oil sheens behind Sanitation Garage yard

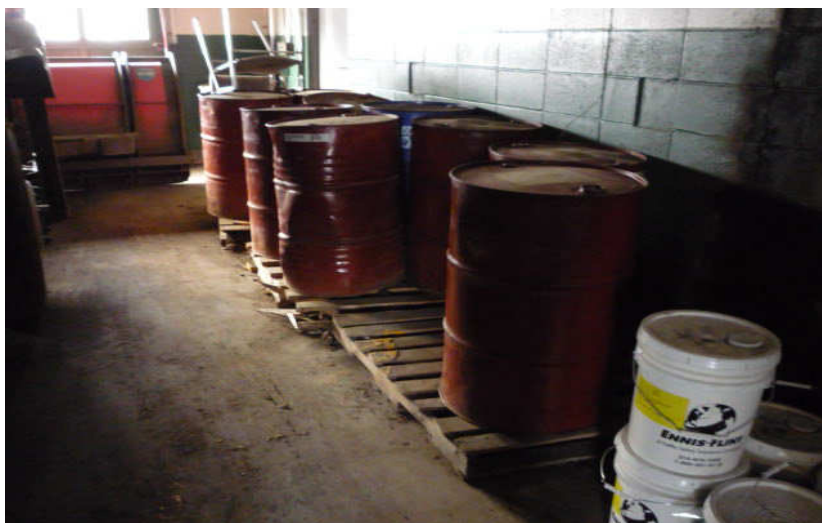
Drums on pallets no containment

3. Within the maintenance and garage areas, any drums containing solvents, lubricants, or oils, should be on drip proof pallets to prevent spills and containment.

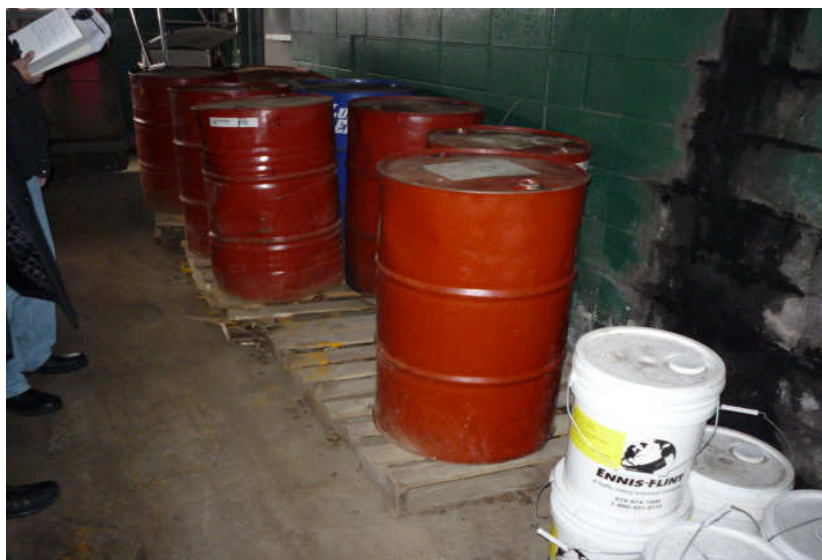
Drums on pallets no containment

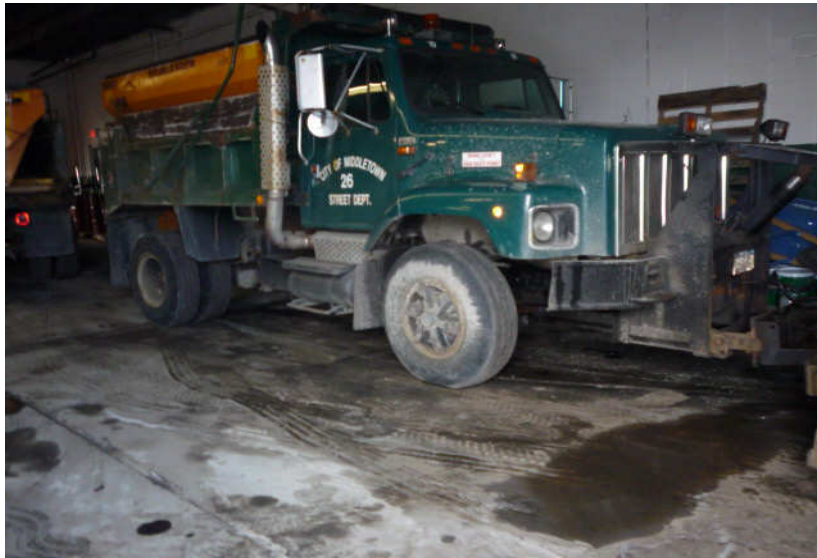
Oil staining within Sanitation Garage

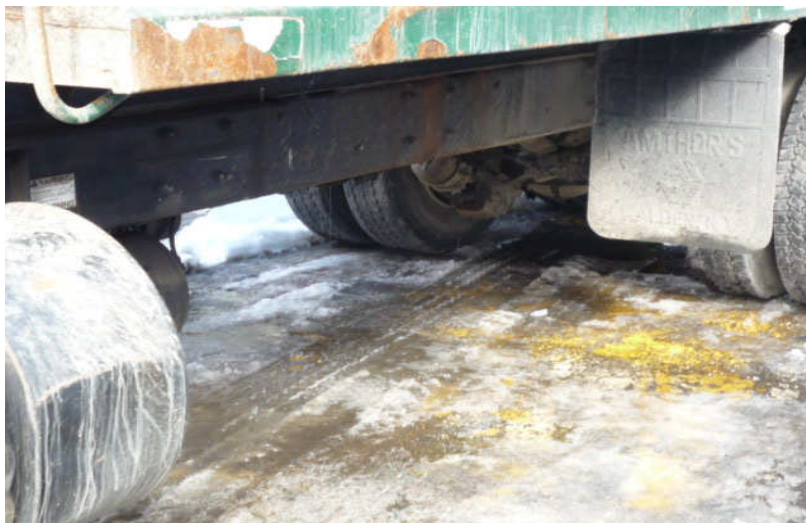
Anti-caking agent (sodium ferrocyanide) was observed behind DPW facility

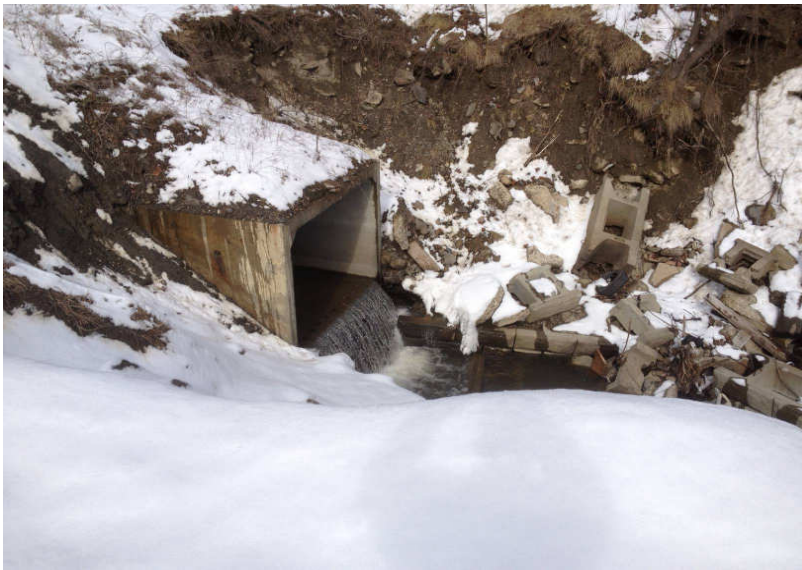
Precast and concrete block due to Hurricane Irene along banks of Monhagen Brook in vicinity of DPW facility

5. Inspectors noted a large accumulation of solid debris and precast structures within the area behind the Sanitation Garage on Main Street, which Middletown officials indicated due to Hurricane Irene. Please provide EPA a tentative schedule for the removal, along with a draft erosion and sediment control plan for this segment of the Monhagen Brook.

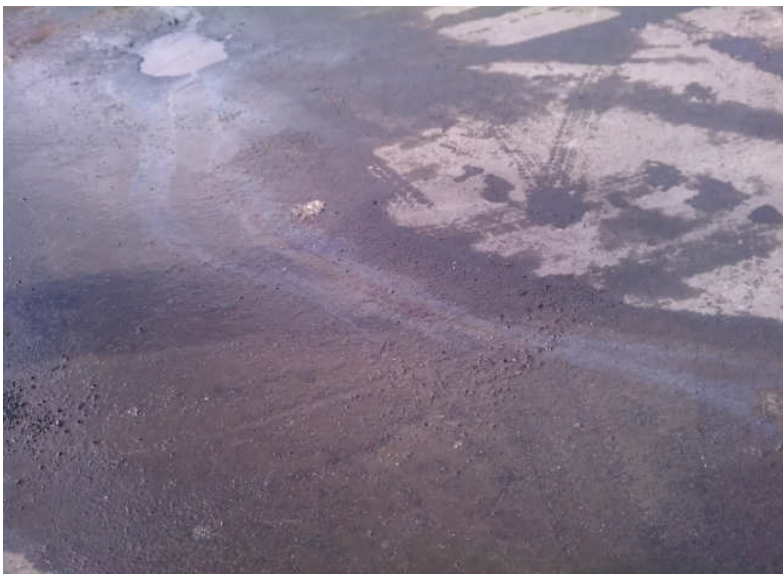
Oil staining behind Sanitation facility

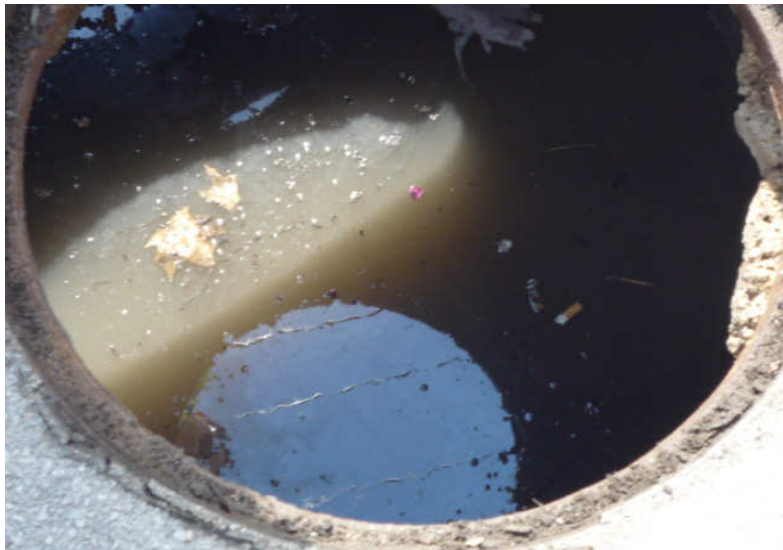
Railroad Road and Cottage Street (near Morse Funeral Home, Inc) sewage filling a catch basin

Catch basin on corner of Cottage Street and Railroad Avenue full of sewage (near Morse Funeral Home)

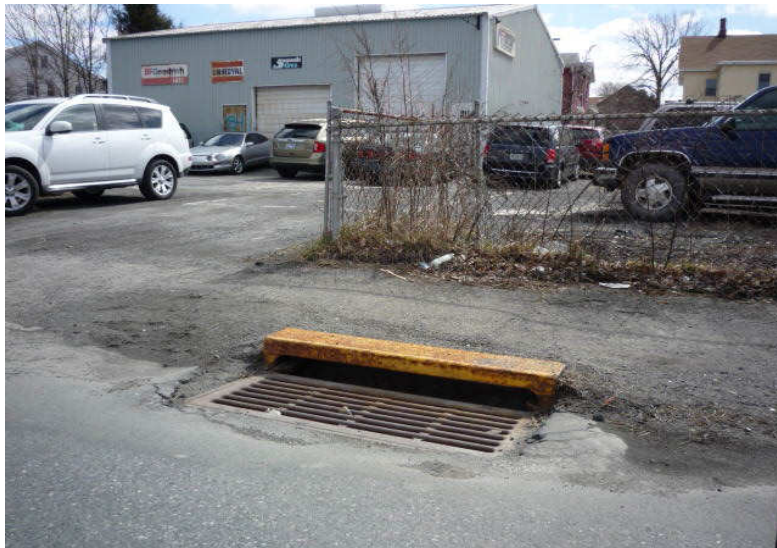
Cottage St. at the railroad crossing (catch basin near Barone's Auto Center) petroleum spill

Catch basin outside of Barone's Auto Center
